Manhole Inspection Summary

Manhole # S43EE_027MH

Location Address: **REAR OF 1704 CHASE ST**

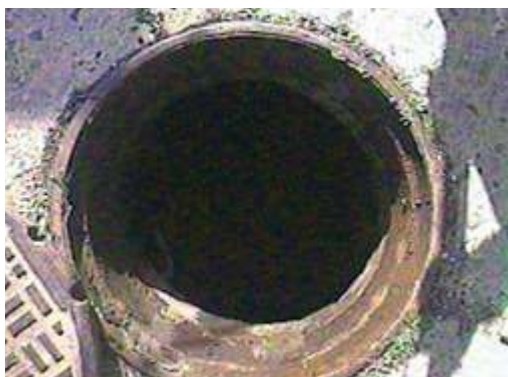
Top View

Condition: ☐ Sound ☐ Cracked ☐ Root Intrusion ☐ Deteriorated ☐ Leaks ☒ **Debris**

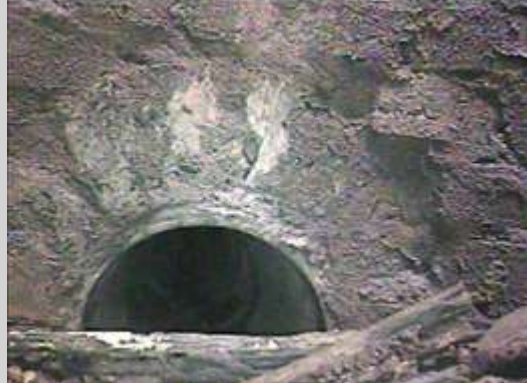
12 O'Clock Outflow

8 in. Circular Gravity Sewer
Pipe Out @ 12 O'Clock

Pipe Material: **Clay** ☐ Pipe Lined

Invert Depth: **7.23** (ft.) Flow Characteristics: **None**

Deposits: ☒ None ☐ Mud ☐ Sludge ☐ Debris ☐ Grease

Infiltration: **None** Pipe Seal Cond: **Sound**
